Development of national significance in the renewable energy sector

Environmental Statement Technical Appendices First Addendum

Penderi Solar Farm,
Land at Blaenhiraeth Farm,
Llangennech, Llanelli, SA14 8PX

DECEMBER 2020 | BRS.4254

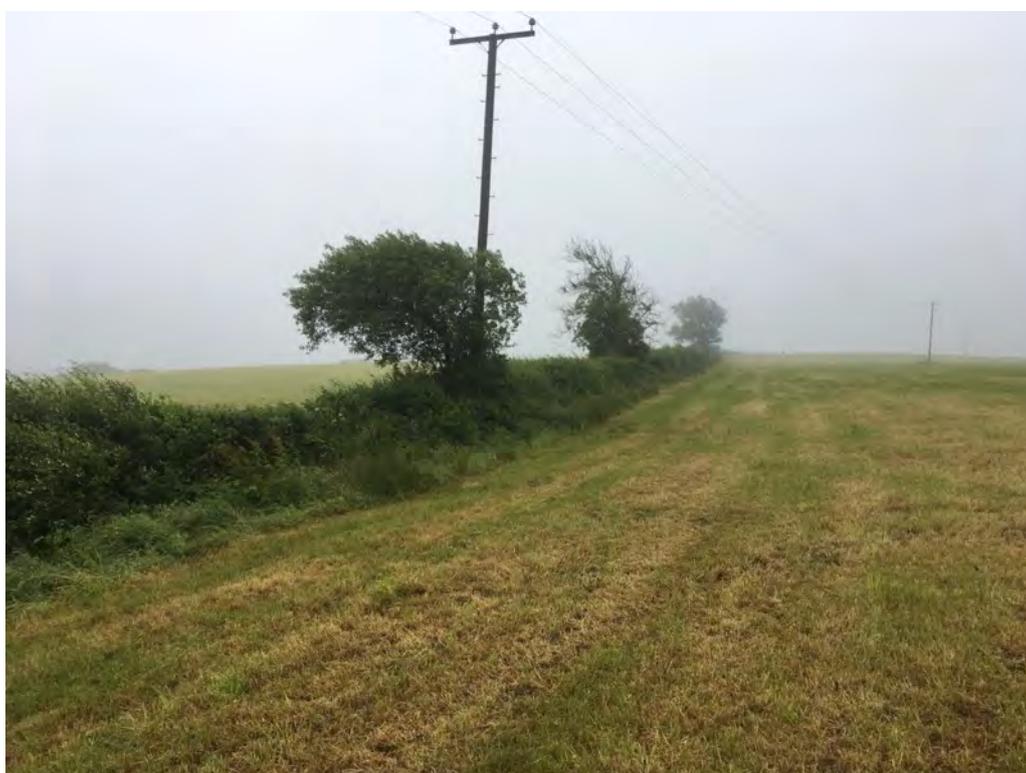
Photoview 1: Looking south from central region of site B. Typical maintained hedgerow with standard trees within this area.

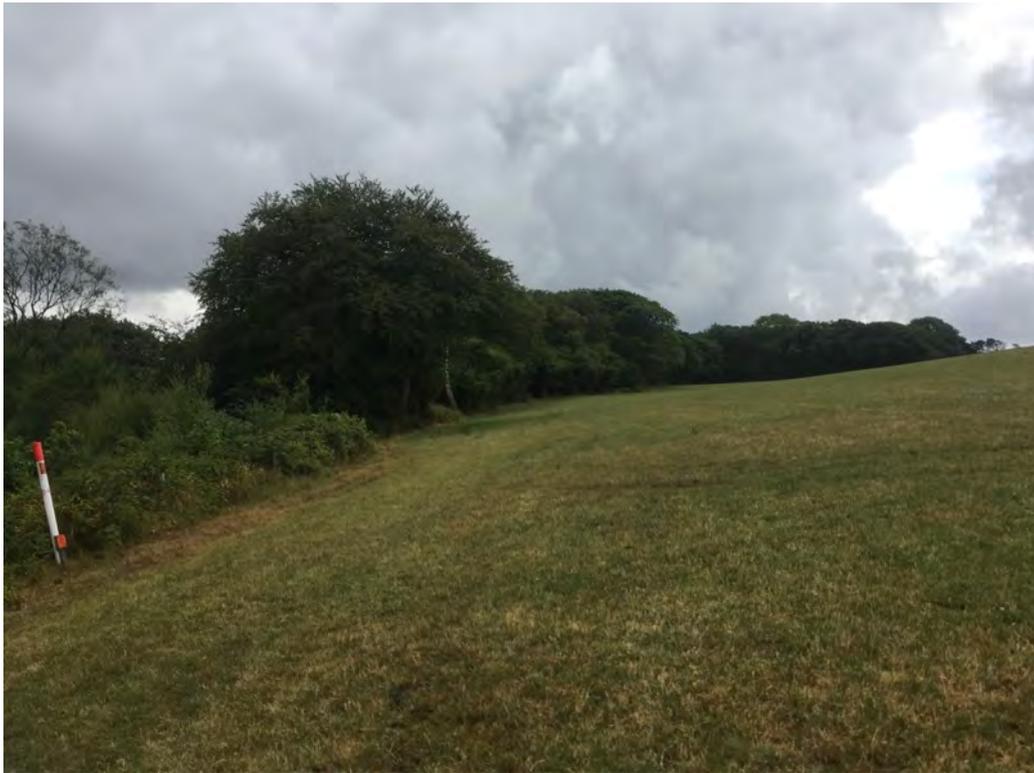
Photoview 2: Looking south from the eastern region of Area B. Note the significant high-quality woodland W47 at centre frame.

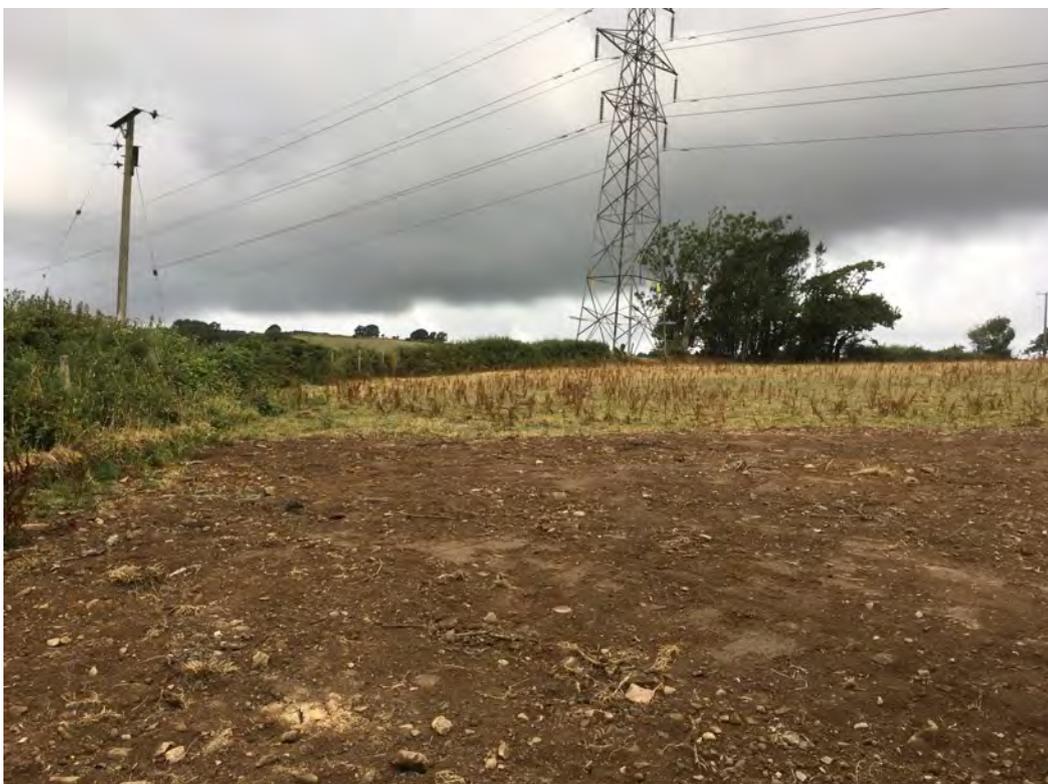
Photoview 3: Area for proposed sub-station to the north of the main farmhouse within area C. Note limited arboricultural constraints within this area except for G6 (adjacent to pylon).

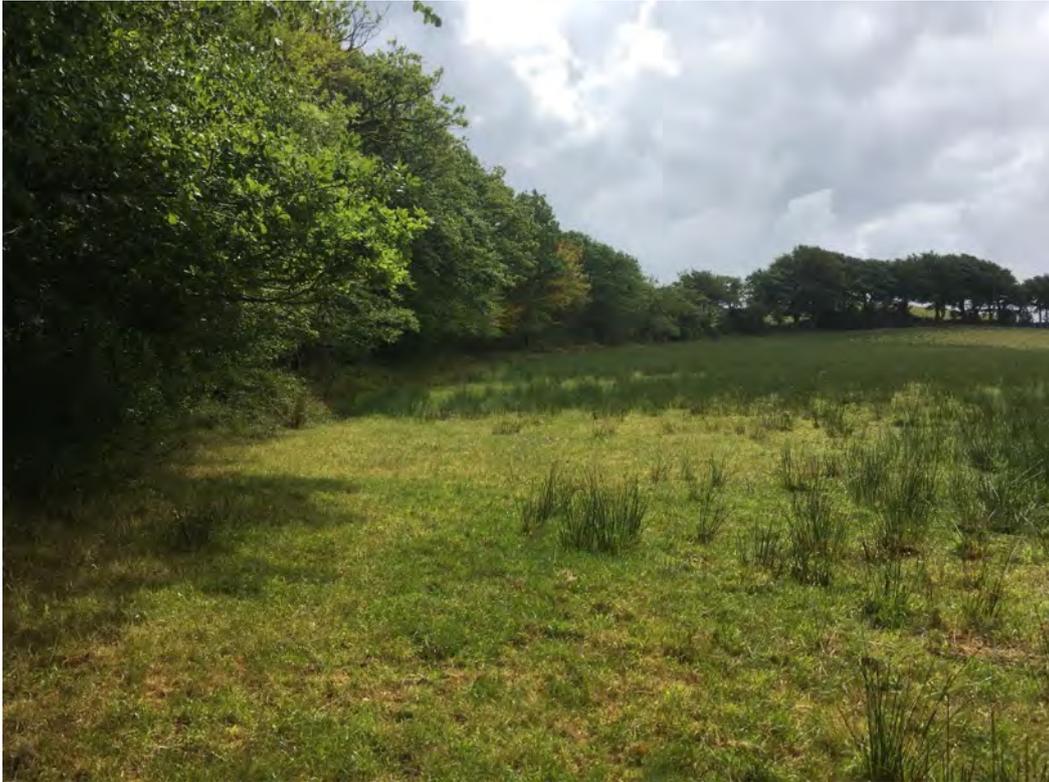
Photoview 4: looking south within the northern region of area B. Note moderate quality group G149 (left of centre) and G150 (right of centre) which are typical groups of trees within this area.

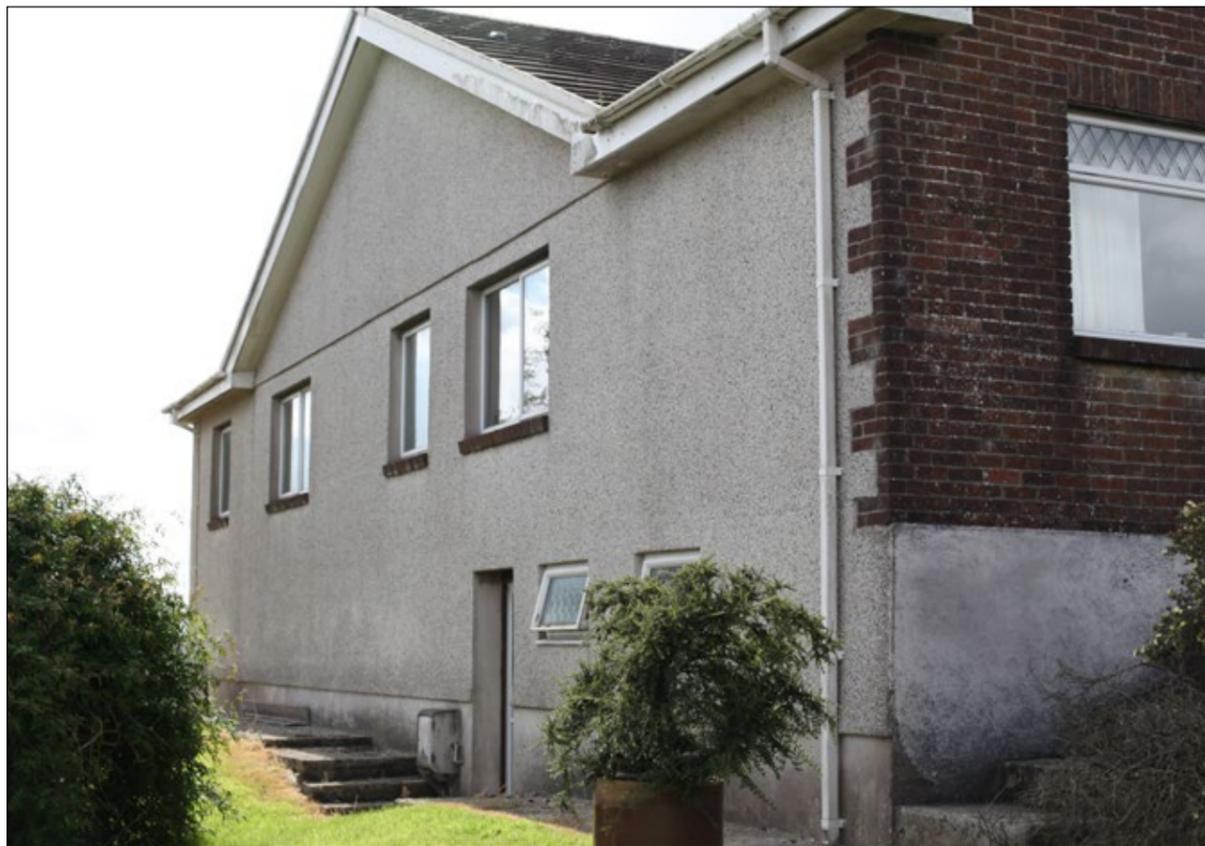
North east elevation

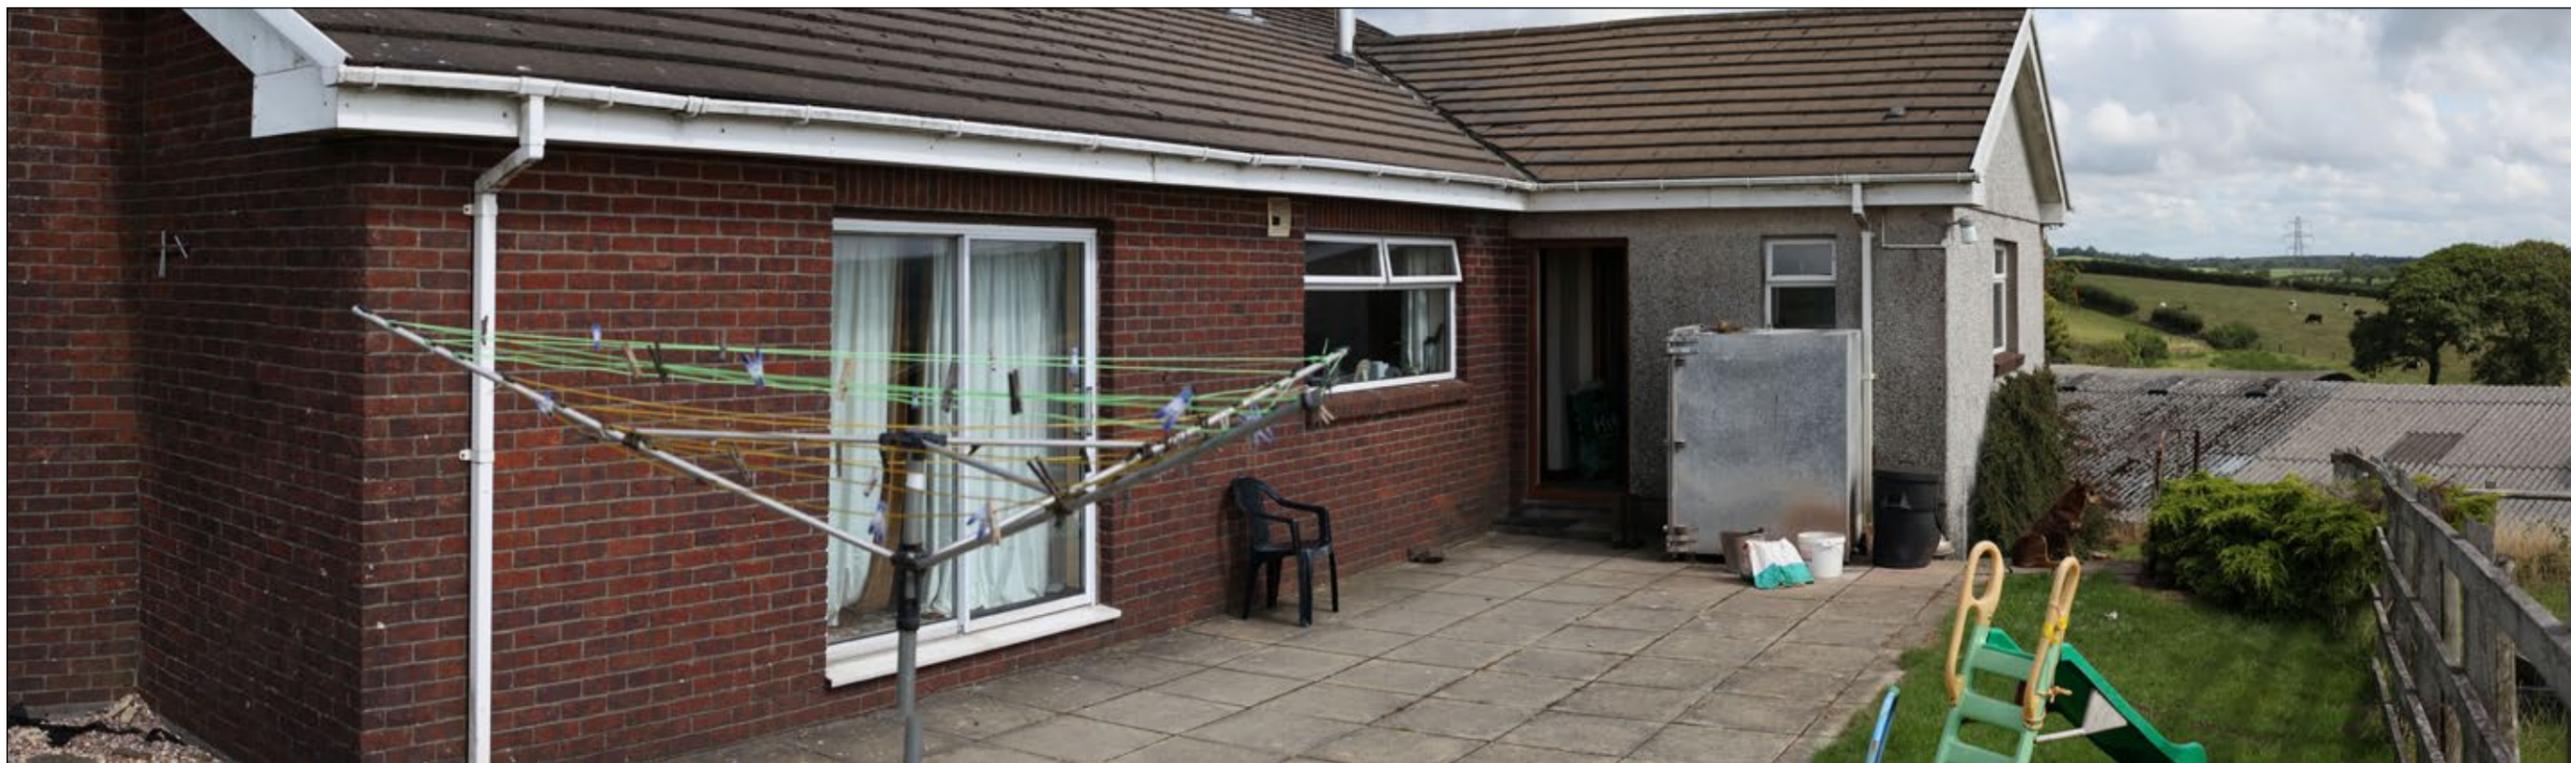
South east elevation

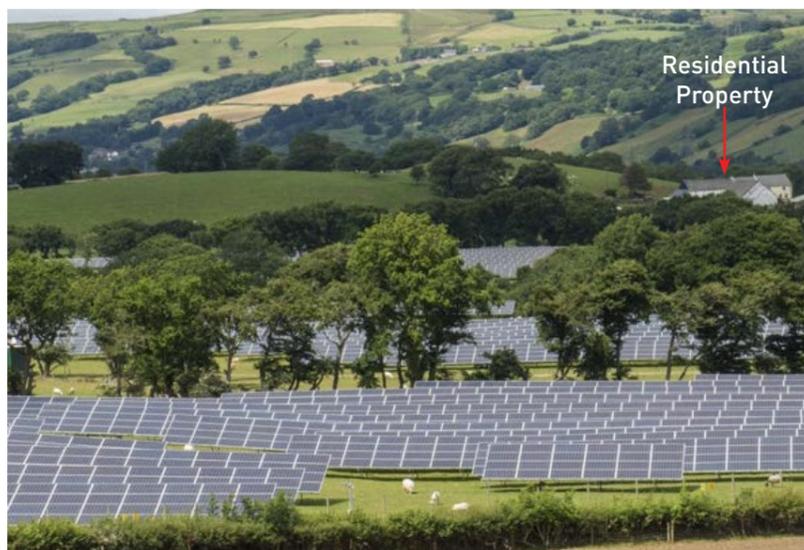
7.3 This photograph from PPW page 10 simply illustrates a general point that solar PV developments can be considered acceptable within close proximity to residential properties without harm to living conditions.

7.2 This document sets out an overview of the planning policy context for Wales. Planning Policy Wales (PPW) Edition 10 was published in December 2018. Page 10, paragraph 1.17 notes that there is a presumption in favour of sustainable development and includes a photograph (replicated below) showing a solar PV development within close proximity to a number of residential properties.

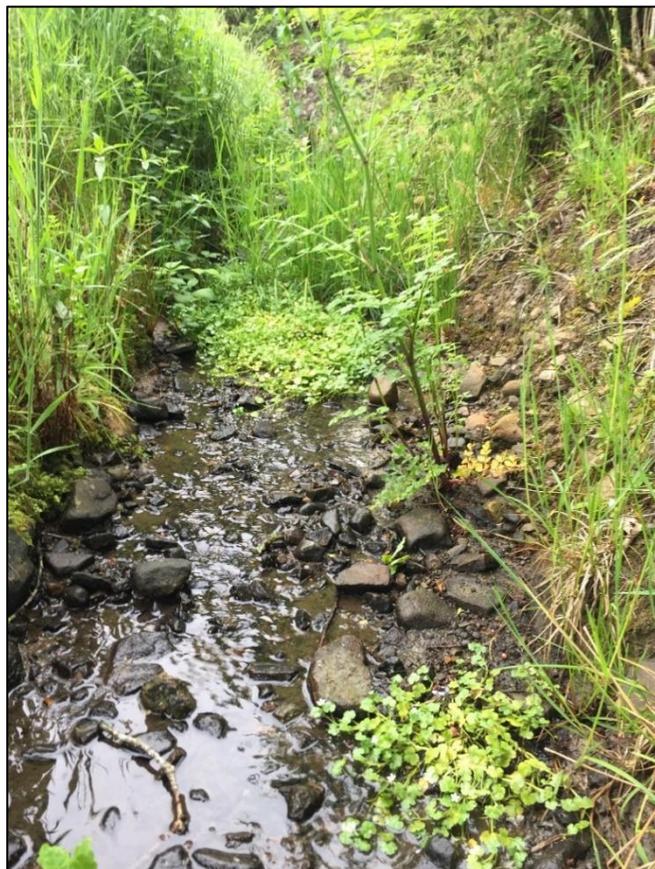
Photograph 3: Showing Wet Ditch (June 2018)

4.4.12 Ditches were present along a majority of the site boundaries, some of which were wet with flowing water, particularly during the winter months, as shown in the photograph below. These larger ditches were mainly present in the north of the site, where they fed into the larger watercourses.

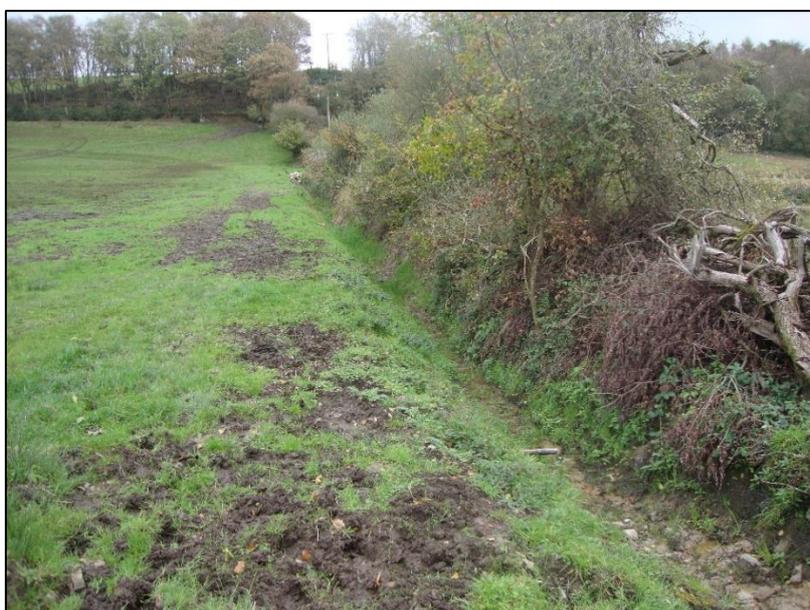
Photograph 4: Dry Ditch at Field Boundary (October 2014)

4.4.13 Smaller ditches were also present at the field boundaries which were smaller, shallower and only likely to hold water during periods of very heavy rainfall, as shown in Photograph 4.

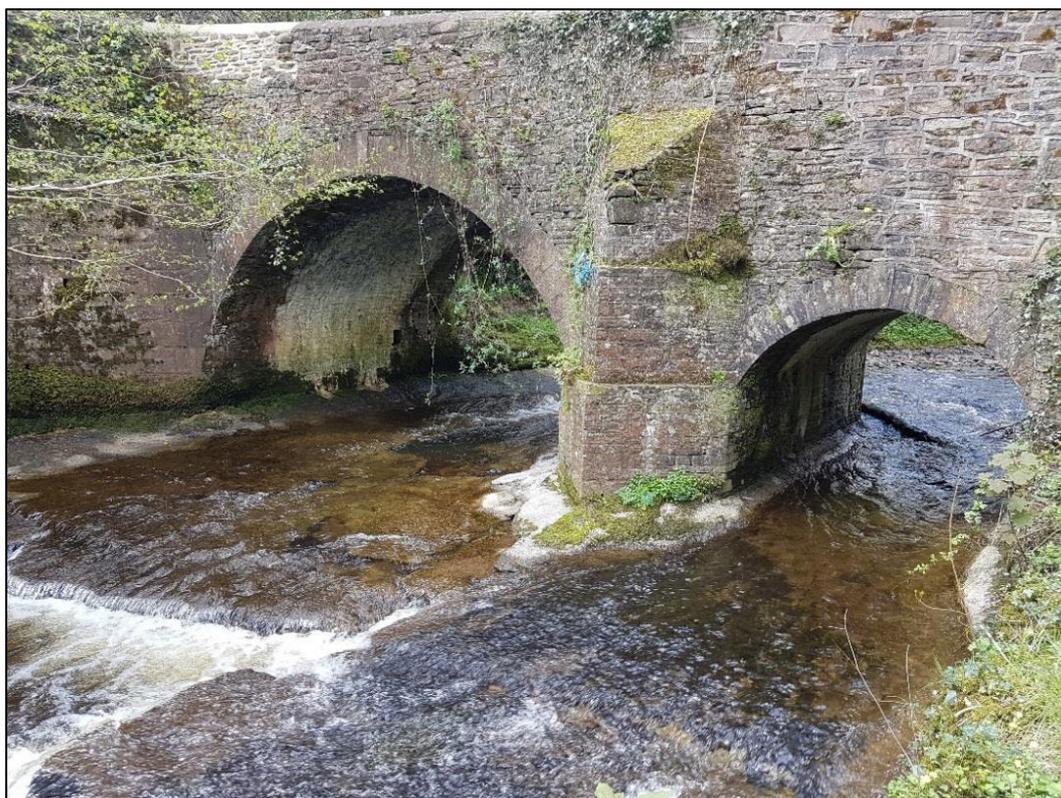
Photograph 5: Stone Bridge Crossing River Afon Morlais with Crevices Suitable for Roosting Bats

- 21.2 At the pre-commencement stage it is intended to carry out a conditional survey of the Bridge structure including all masonry and parapets and then to drill a series of 16mm pilot holes to confirm the depth of the road makeup at the crown. This will verify whether a depth of 350mm from the crown is achievable for the open cut trenching. If the necessary depth for the open-cut trenching cannot be undertaken, then the alternative directional drill option under the river Morlais will be implemented. Trenchless drilling has the advantage of minimising impacts to surface areas and reducing the levels of reinstatement requirement. It is a well-established and appropriate technique for crossing difficult terrains and sensitive features.

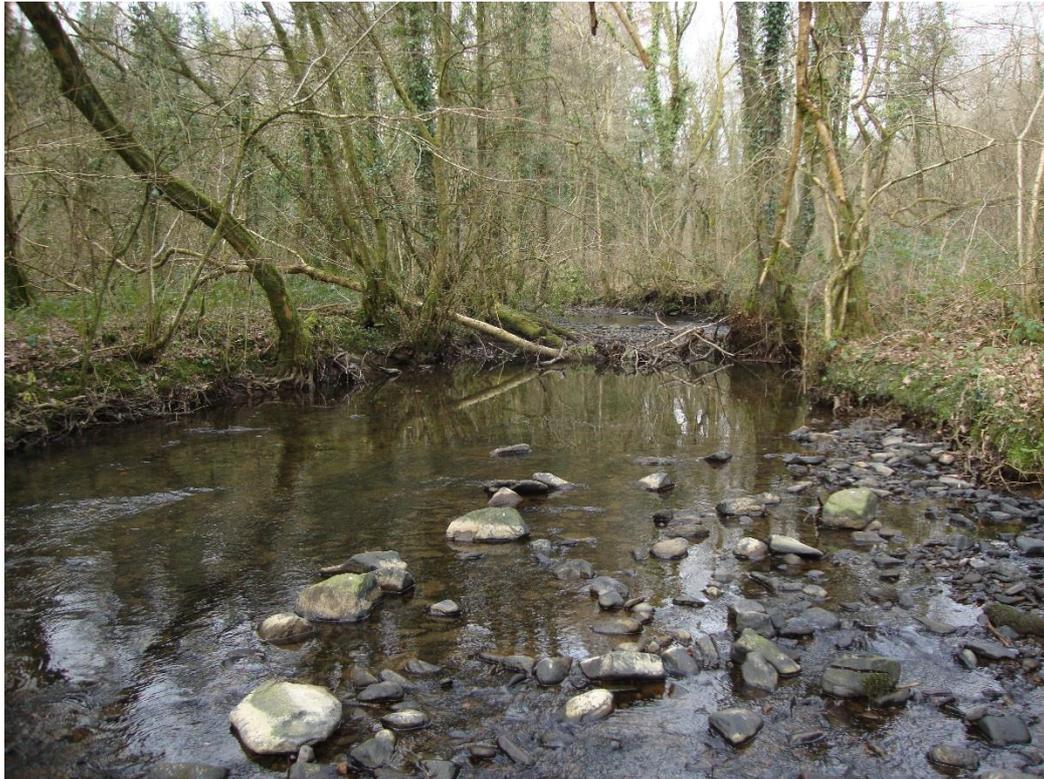
Photograph 6: River Afon Morlais (February 2015)

- 4.5.18 The Afon Morlais river (shown in Photograph 6) crosses the site under a bridge (as shown in TN45, Figure 4). The river at this point is fast flowing and very shallow during the summer months, with very little bankside vegetation. It is considered unsuitable for water voles at this point but may be more suitable up or down stream. This river is considered to be most suitable for otters, although no spraints have been recorded at the bridge, where there are suitable marking substrates which otters are known to favour. A photograph of this river habitat is shown overleaf.

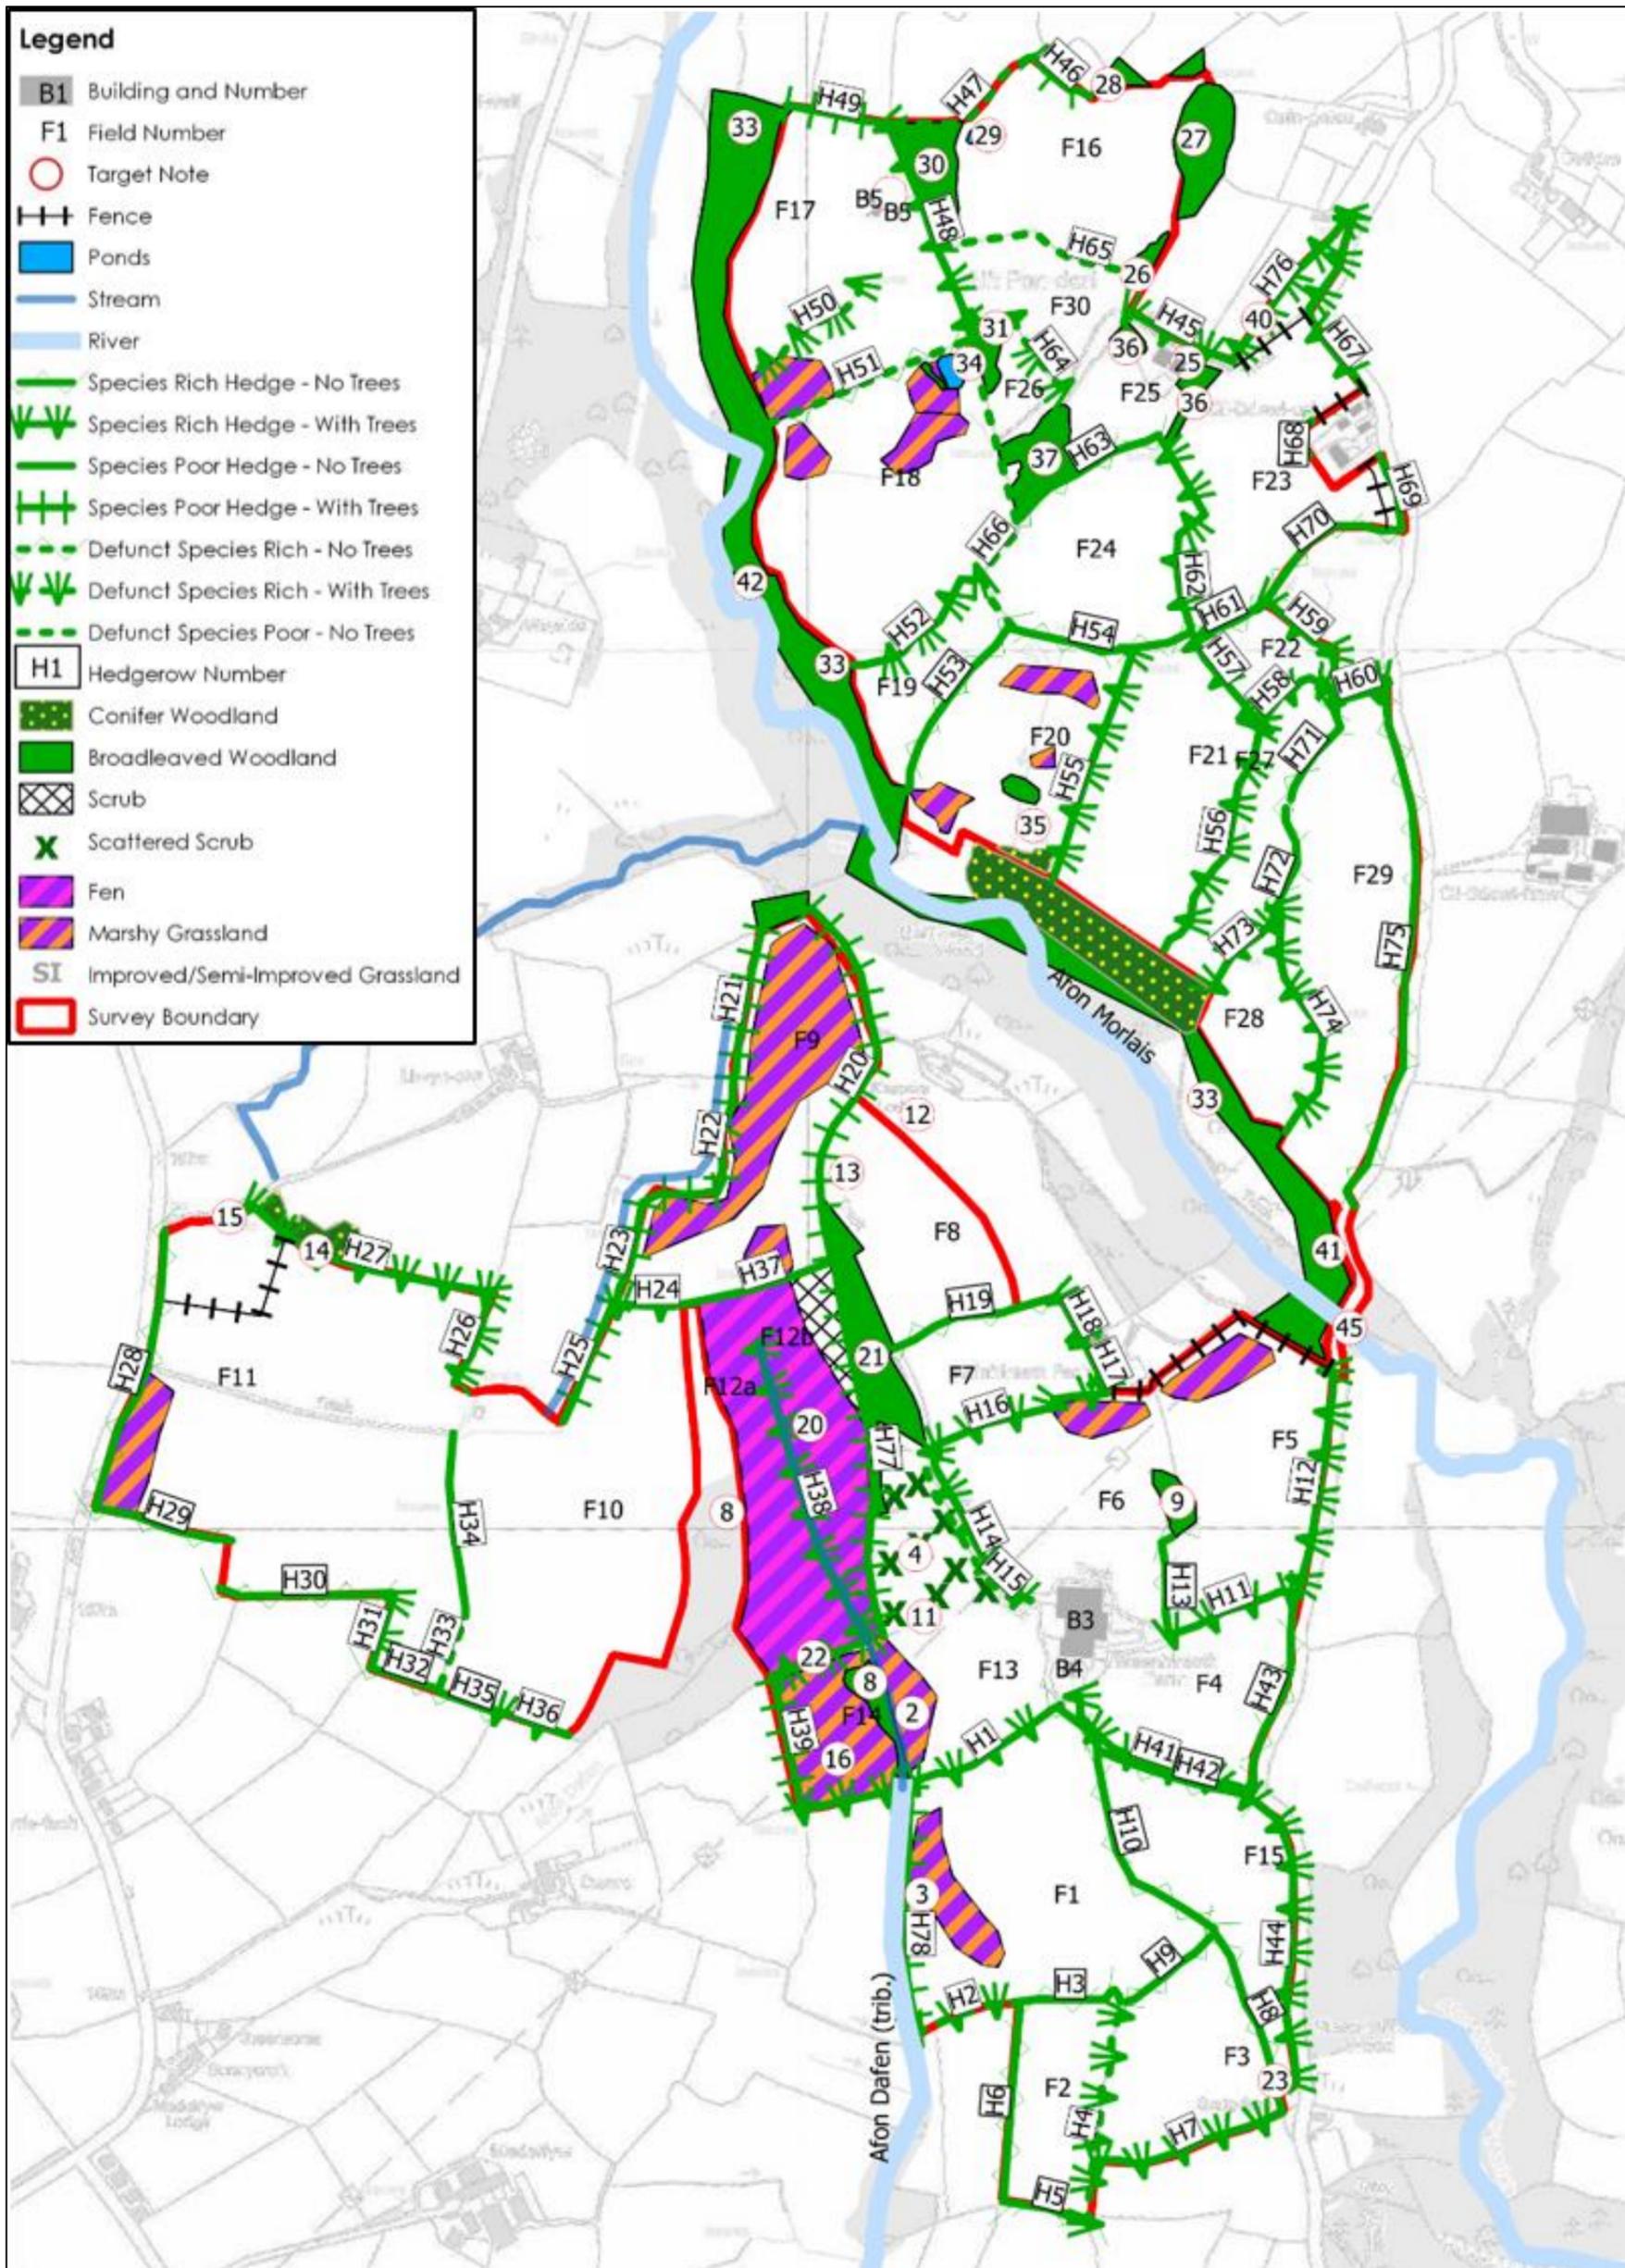
Figure 4: Phase 1 Map of Site (Target Notes Overleaf)

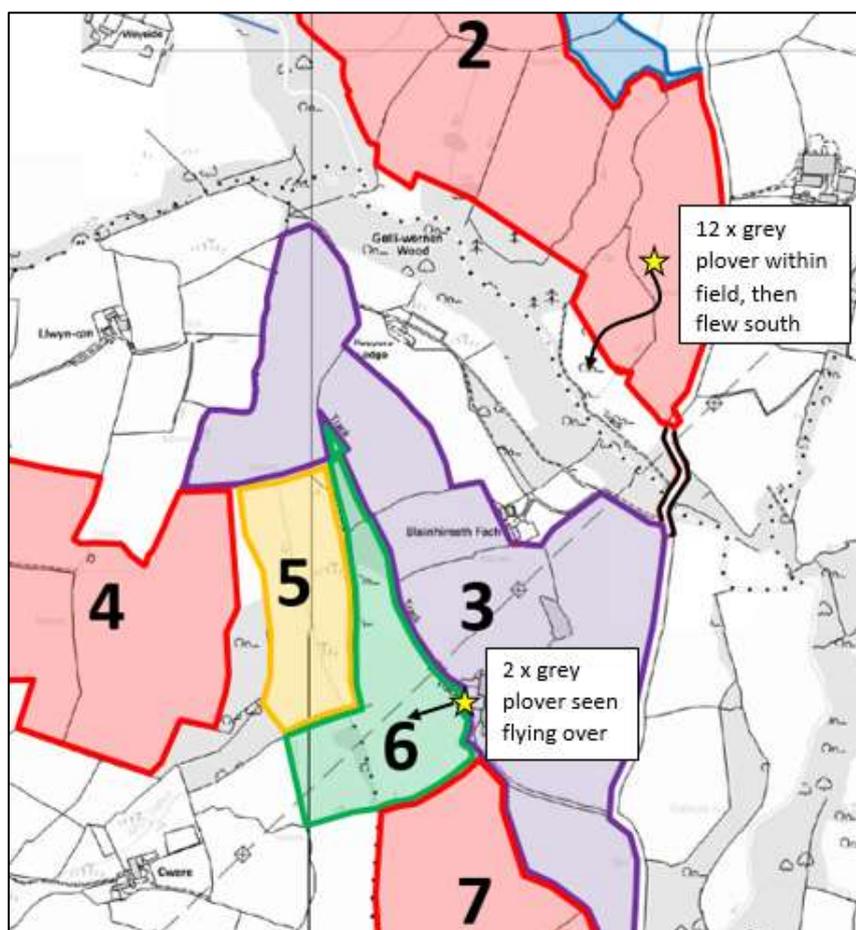
Figure 2: Location of Grey Plovers Recorded During Visit 4

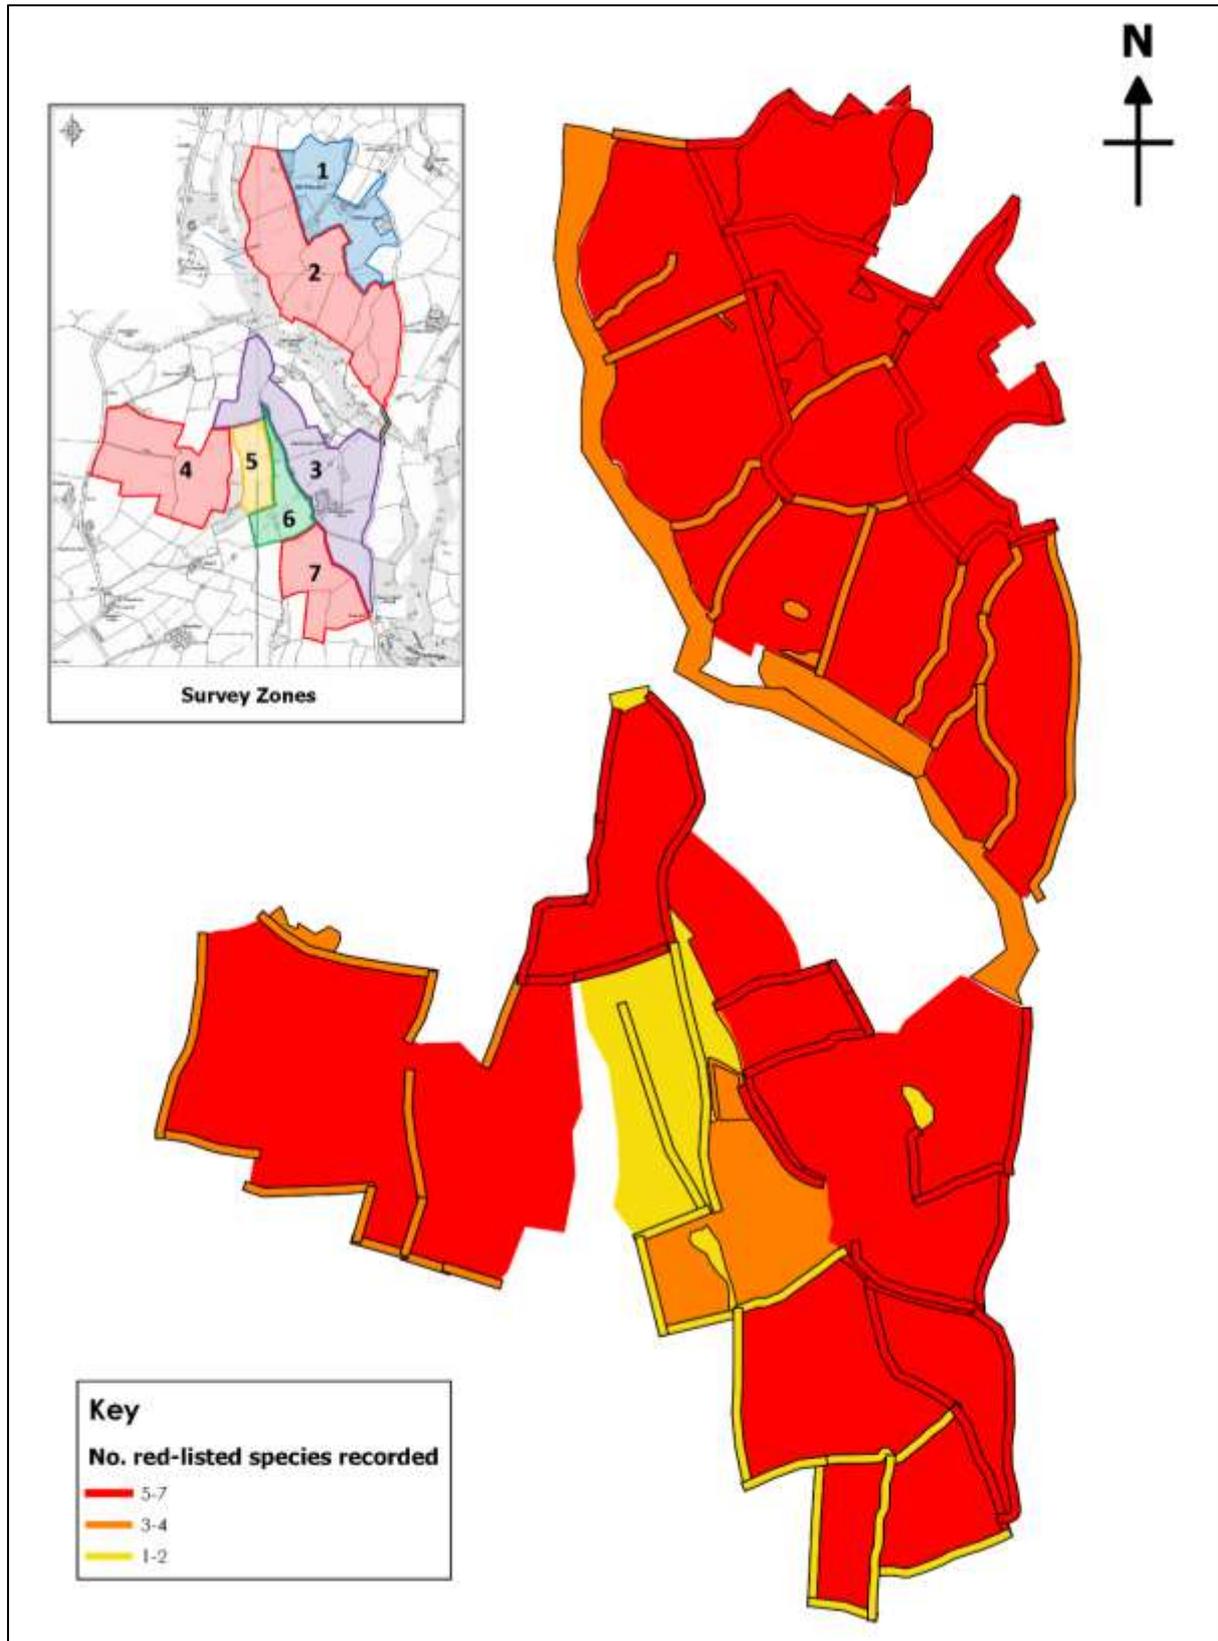
Figure 2: Diversity of red-listed species in different survey zones of the site, subdivided by broad habitat type

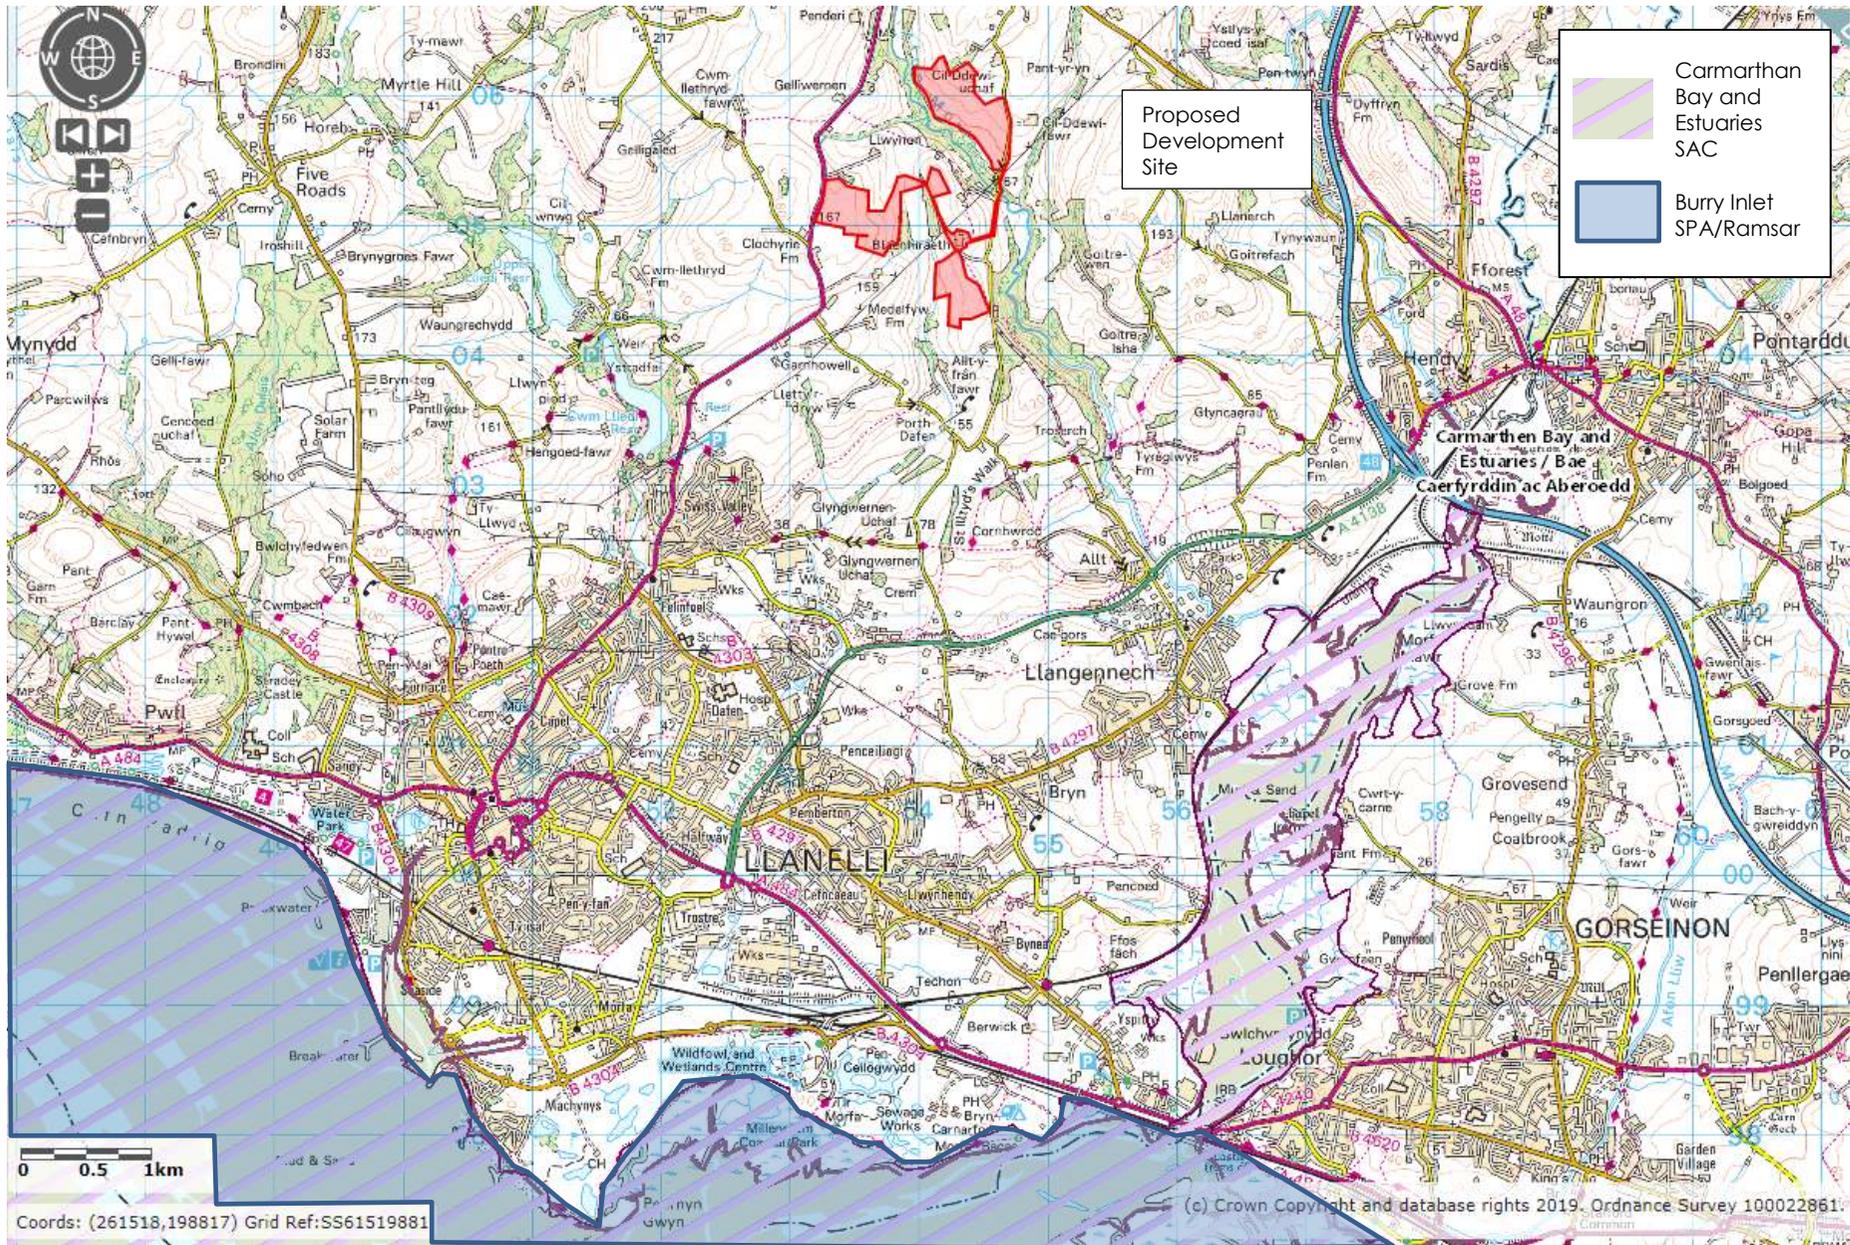
Location of Proposed Development Site and SAC/SPA/Ramsar with Afon Morlais Tributary Connecting

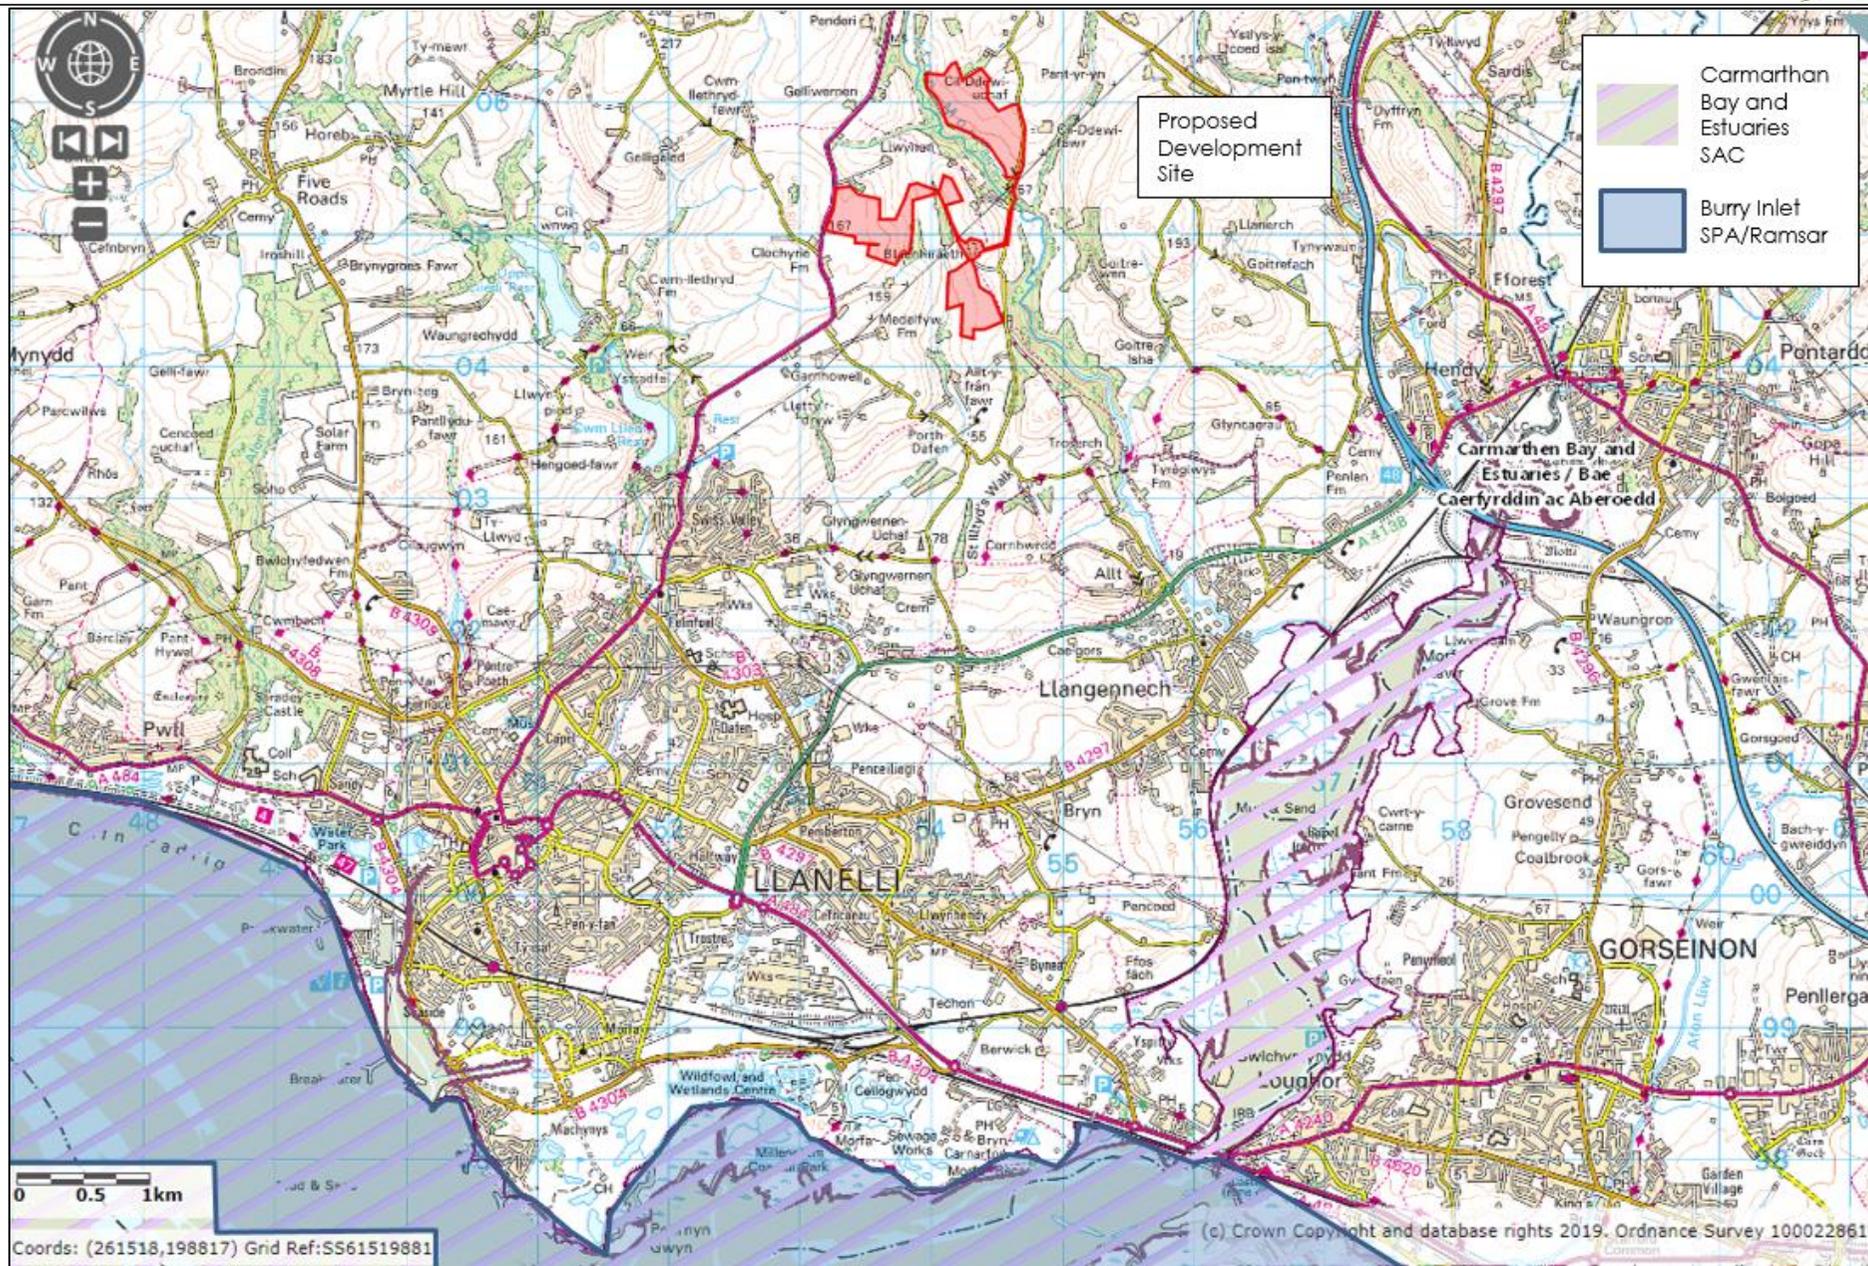
Figure 3: Location of Proposed Development Site and SAC/SPA/Ramsar with Afon Morlais Tributary Connecting

2.1.1 The habitats within the site are not directly associated with the SAC or SPA/Ramsar, however, the streams which lie adjacent to the site feed into the Carmarthen Bay and Estuaries SAC approximately 5.1km downstream. This then feeds into the Burry Inlet SPA/Ramsar approximately 10.4km downstream, as shown in Figure 3 overleaf.

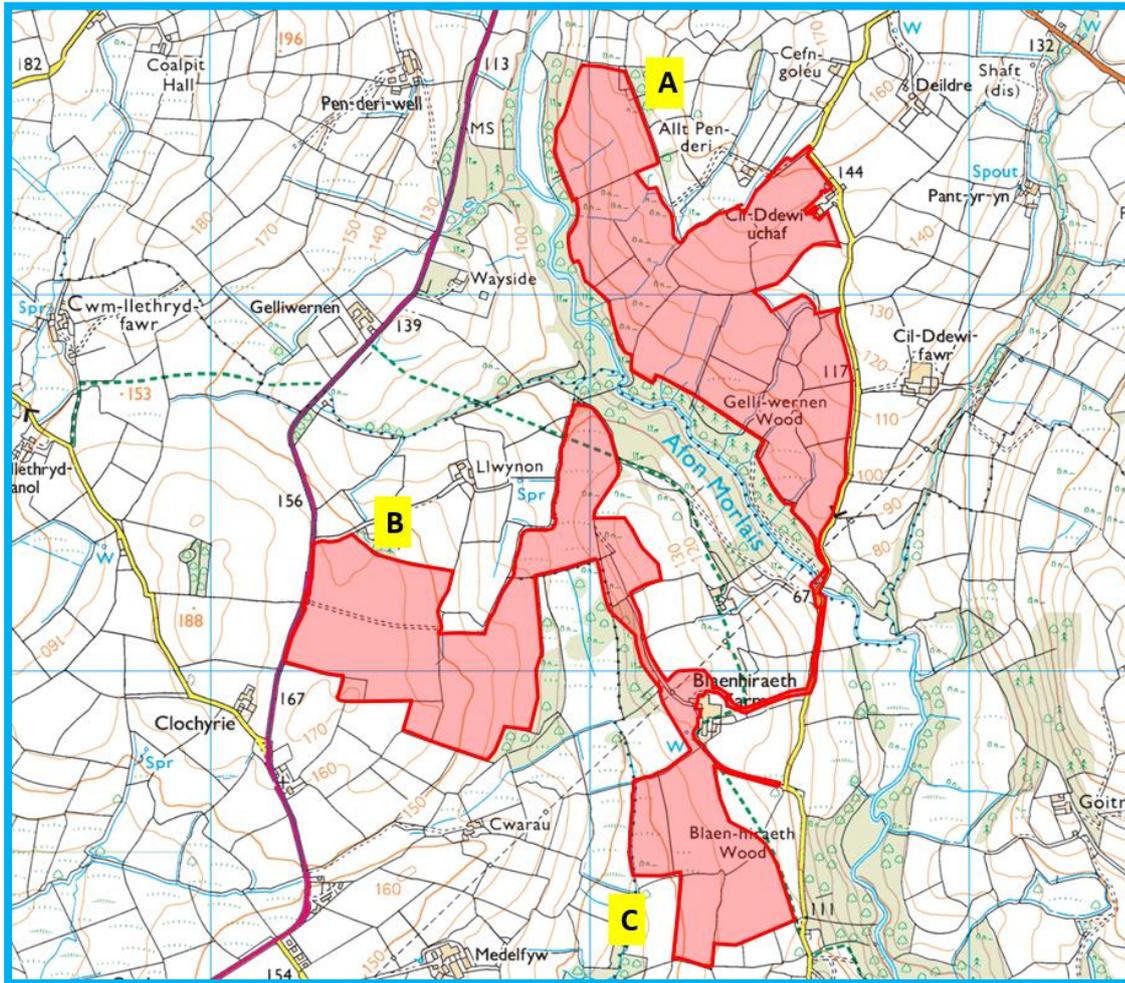
Fig 2 Site location identifying the 3 parts A, B and C. Note interlinking routes for access and cables between B and C, but along the existing lane for connection to A (Streetmap).
