Development of national significance in the renewable energy sector

Environmental Statement Technical Appendices First Addendum

Penderi Solar Farm,
Land at Blaenhiraeth Farm,
Llangennech, Llanelli, SA14 8PX

DECEMBER 2020 | BRS.4254

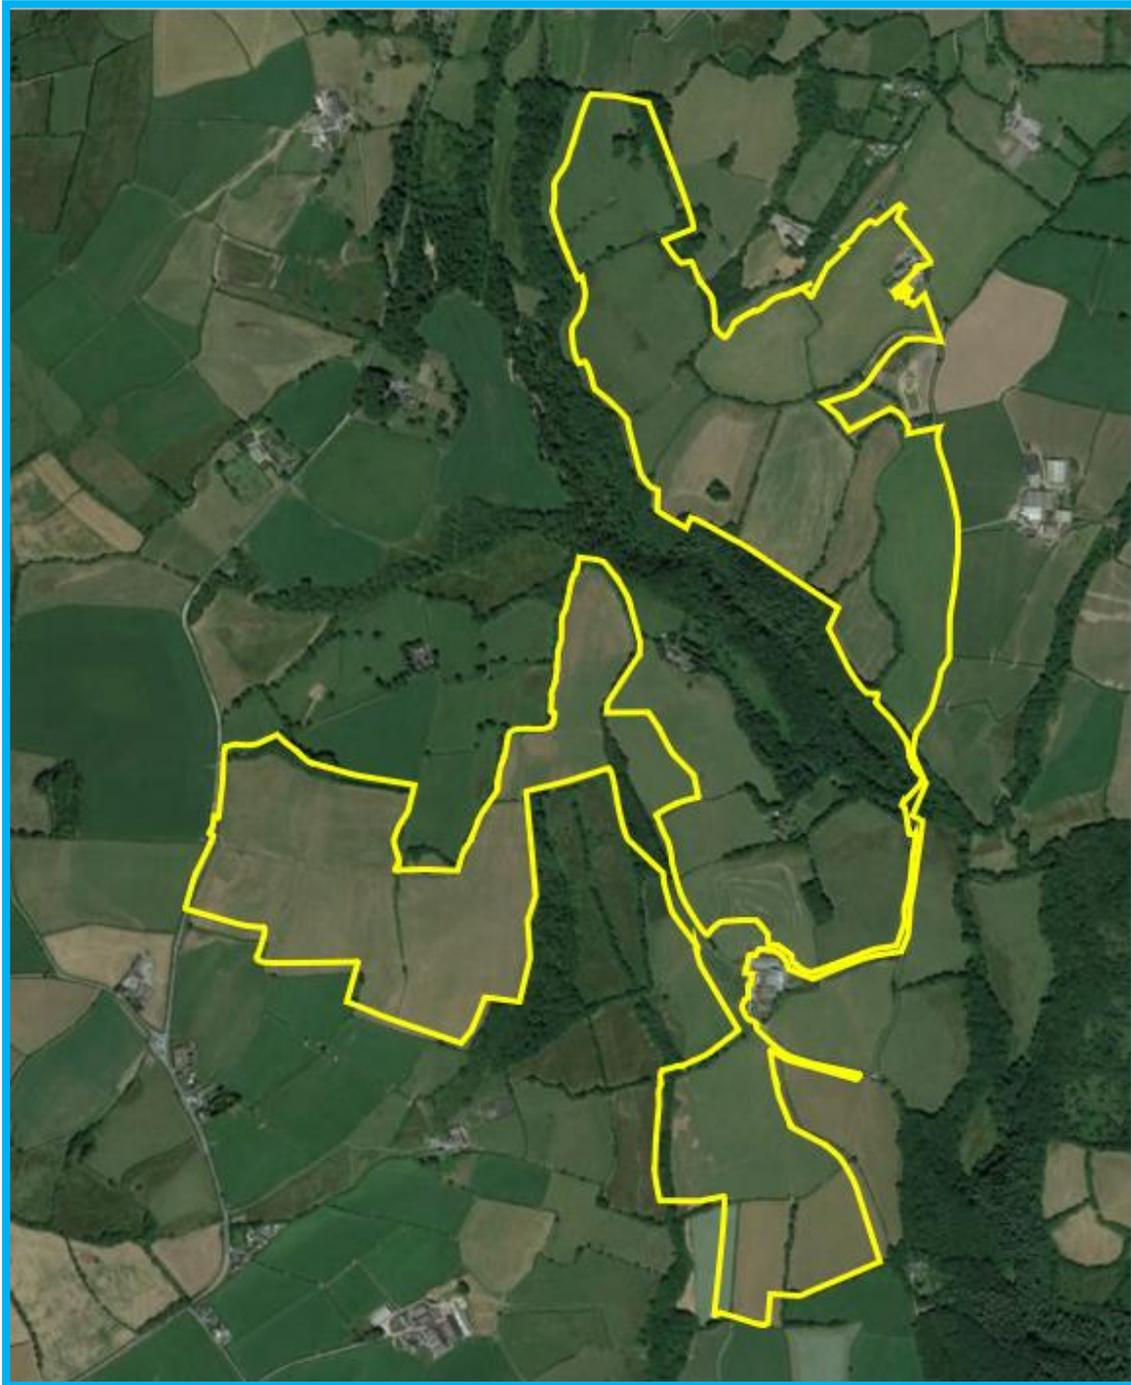
Fig 3 Site located on satellite view, showing rural area. Note outline is approximate to field boundaries due to distortions of background image (2019 Google image).

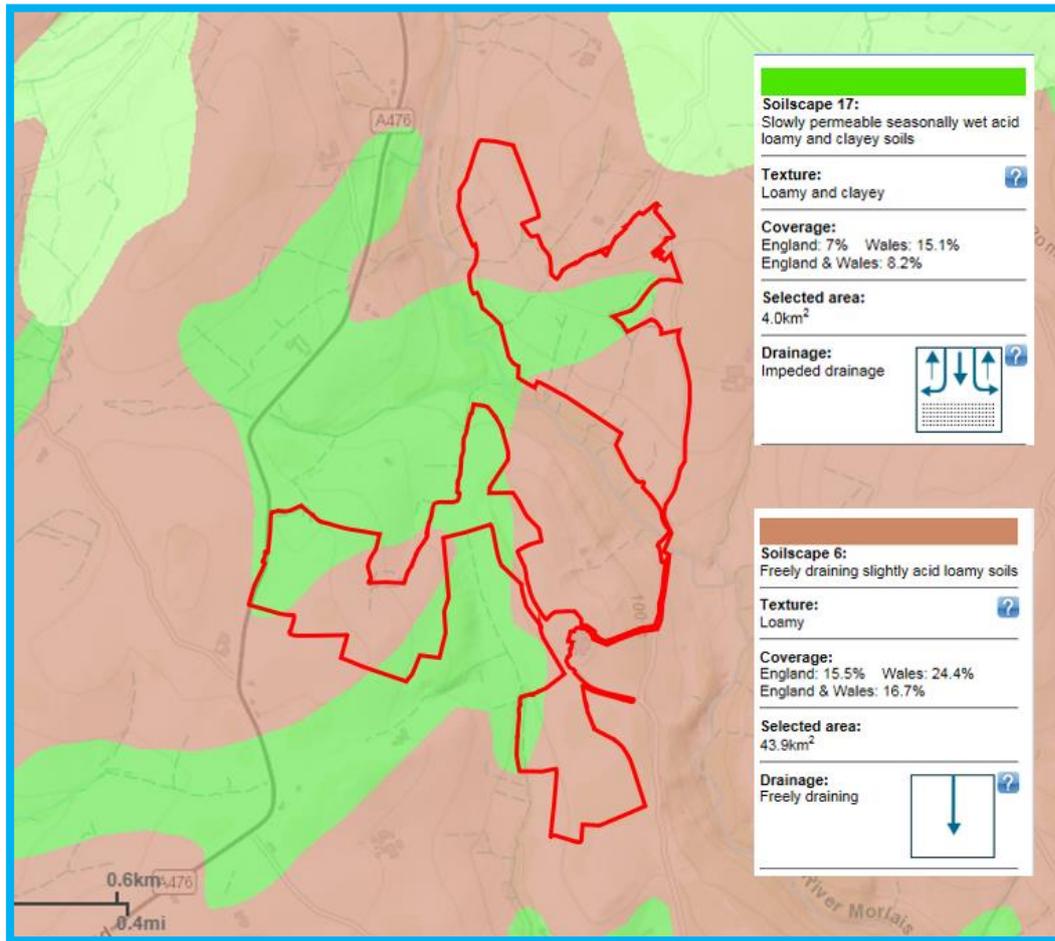
Fig 4 Site located on Soilscales viewer, showing the area to be mainly free draining (brown), with some localised areas of impeded drainage (green), which are likely to be marshy where shallow gradients occur.

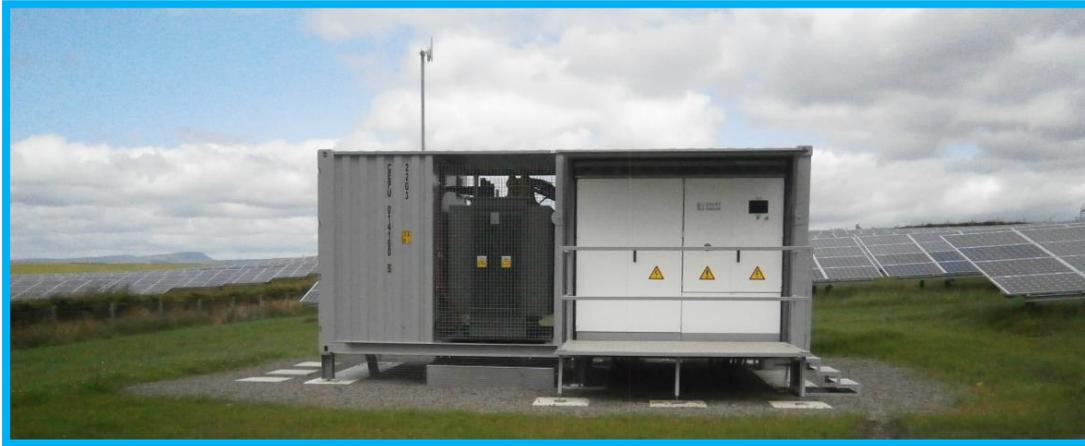
Part B and Part C will also have containerised transformer units on legs on concrete pads within a 300mm thick permeable gravel.

Fig 5 Typical transformer installation on raised legs with permeable gravel base area (Merthyr Tydfil).

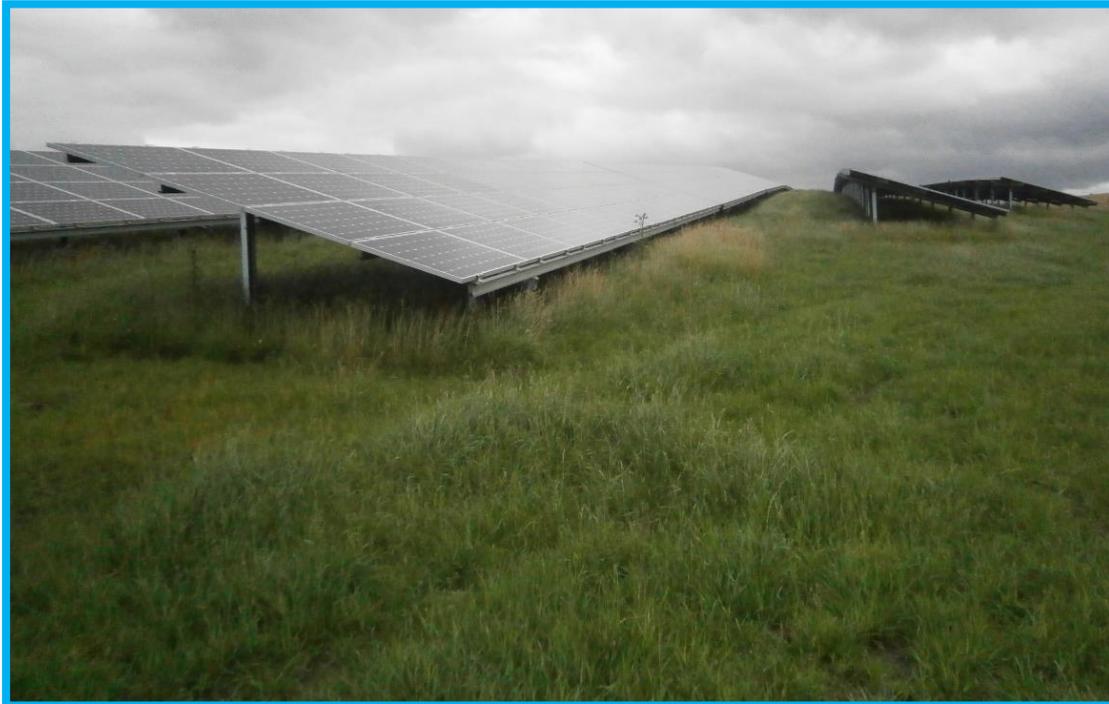
Fig 11 Solar arrays on 1 in 8 slope showing flourishing vegetation (Merthyr Tydfil).

It has been recognised that solar farms do not increase runoff; indeed, as the vegetation establishes and improves soil properties, the runoff is reduced from previous farming levels and the natural catchment characteristics are restored.
